NRL/MR/6120--97-7957

Control of Lead in Drinking Water

13. ABSTRACT (Maximum 200 words) This report describes the installation of an NRL-developed epoxy lining in the drinking water distribution system in three buildings. Water was sampled before and after installation of the lining; the sampling data was interpreted after several confounding factors were identified and allowed for. Improper installation of the lining in one of the buildings led to its premature failure, and this was documented and analyzed. The lining is shown to be effective in preventing leaching of lead into drinking water. This technology is recommended as a routine method for excluding lead from drinking water distribution systems in buildings, and guidance for use in establishing contracts to install the lining is provided.

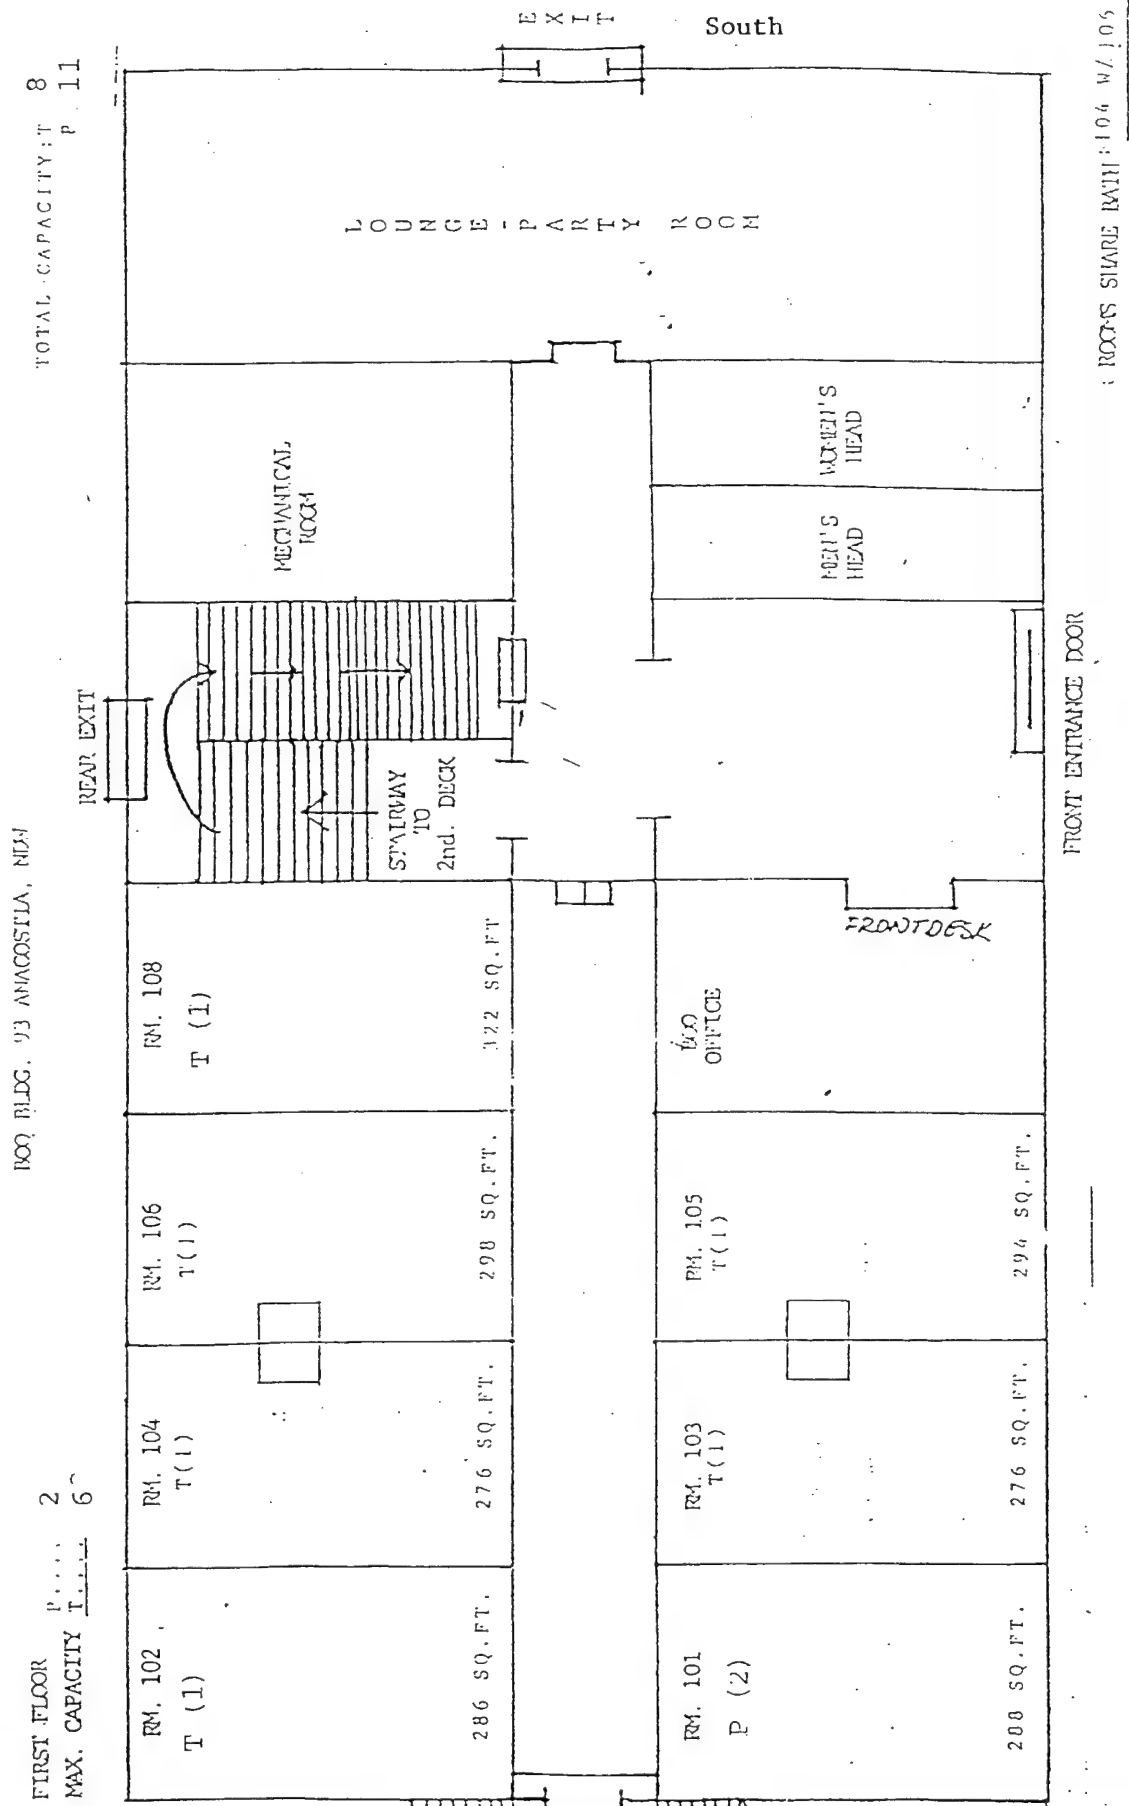
Figure 1a

Building A93 is a Bachelor Officers Quarters which contains 23 sleeping rooms. A floor plan is shown in Figures 1a (first floor) and 1b (second floor) and a plumbing diagram is shown in Figure 2. The building contains 15 private and 4 semi-private bathrooms. The building also has a mechanical room, janitor's closet, wet bar, laundry, and men's and ladies' restrooms on the first floor, and a janitor's closet, laundry and kitchen on the second floor. Neither Figure 1 nor Figure 2 is to scale.

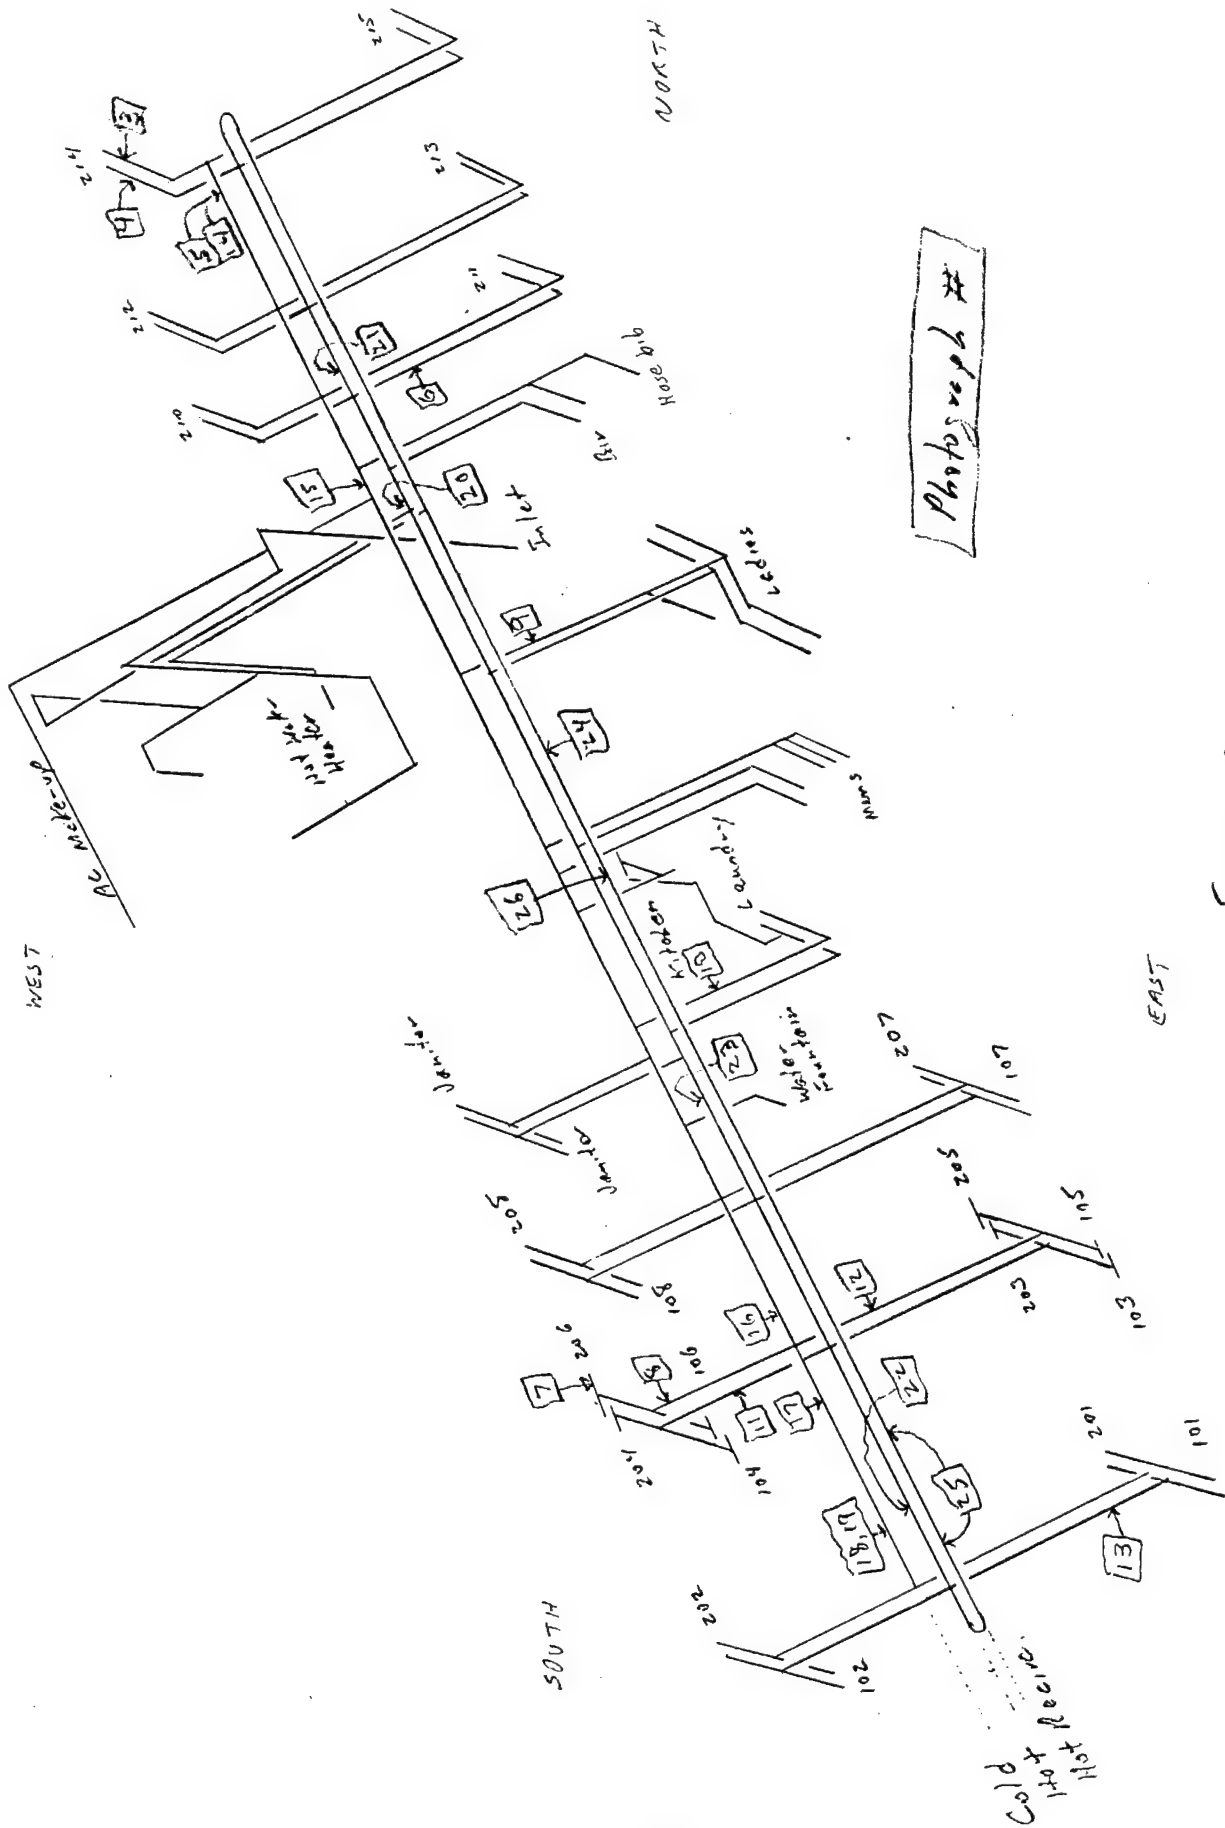
Figure 2

In the photographs used to document the condition of the piping, the lighting and camera angle were chosen to best capture the appearance of the lining and the pipe. Pipes usually needed to be rotated from their position in the building to accomplish this. Do not assume that the top of the pipe in a photograph is the same as the top of the pipe when it was installed in the building. In Figure 2, numbered boxes correspond to Figures 3 - 26 and show where piping was removed for photographs.

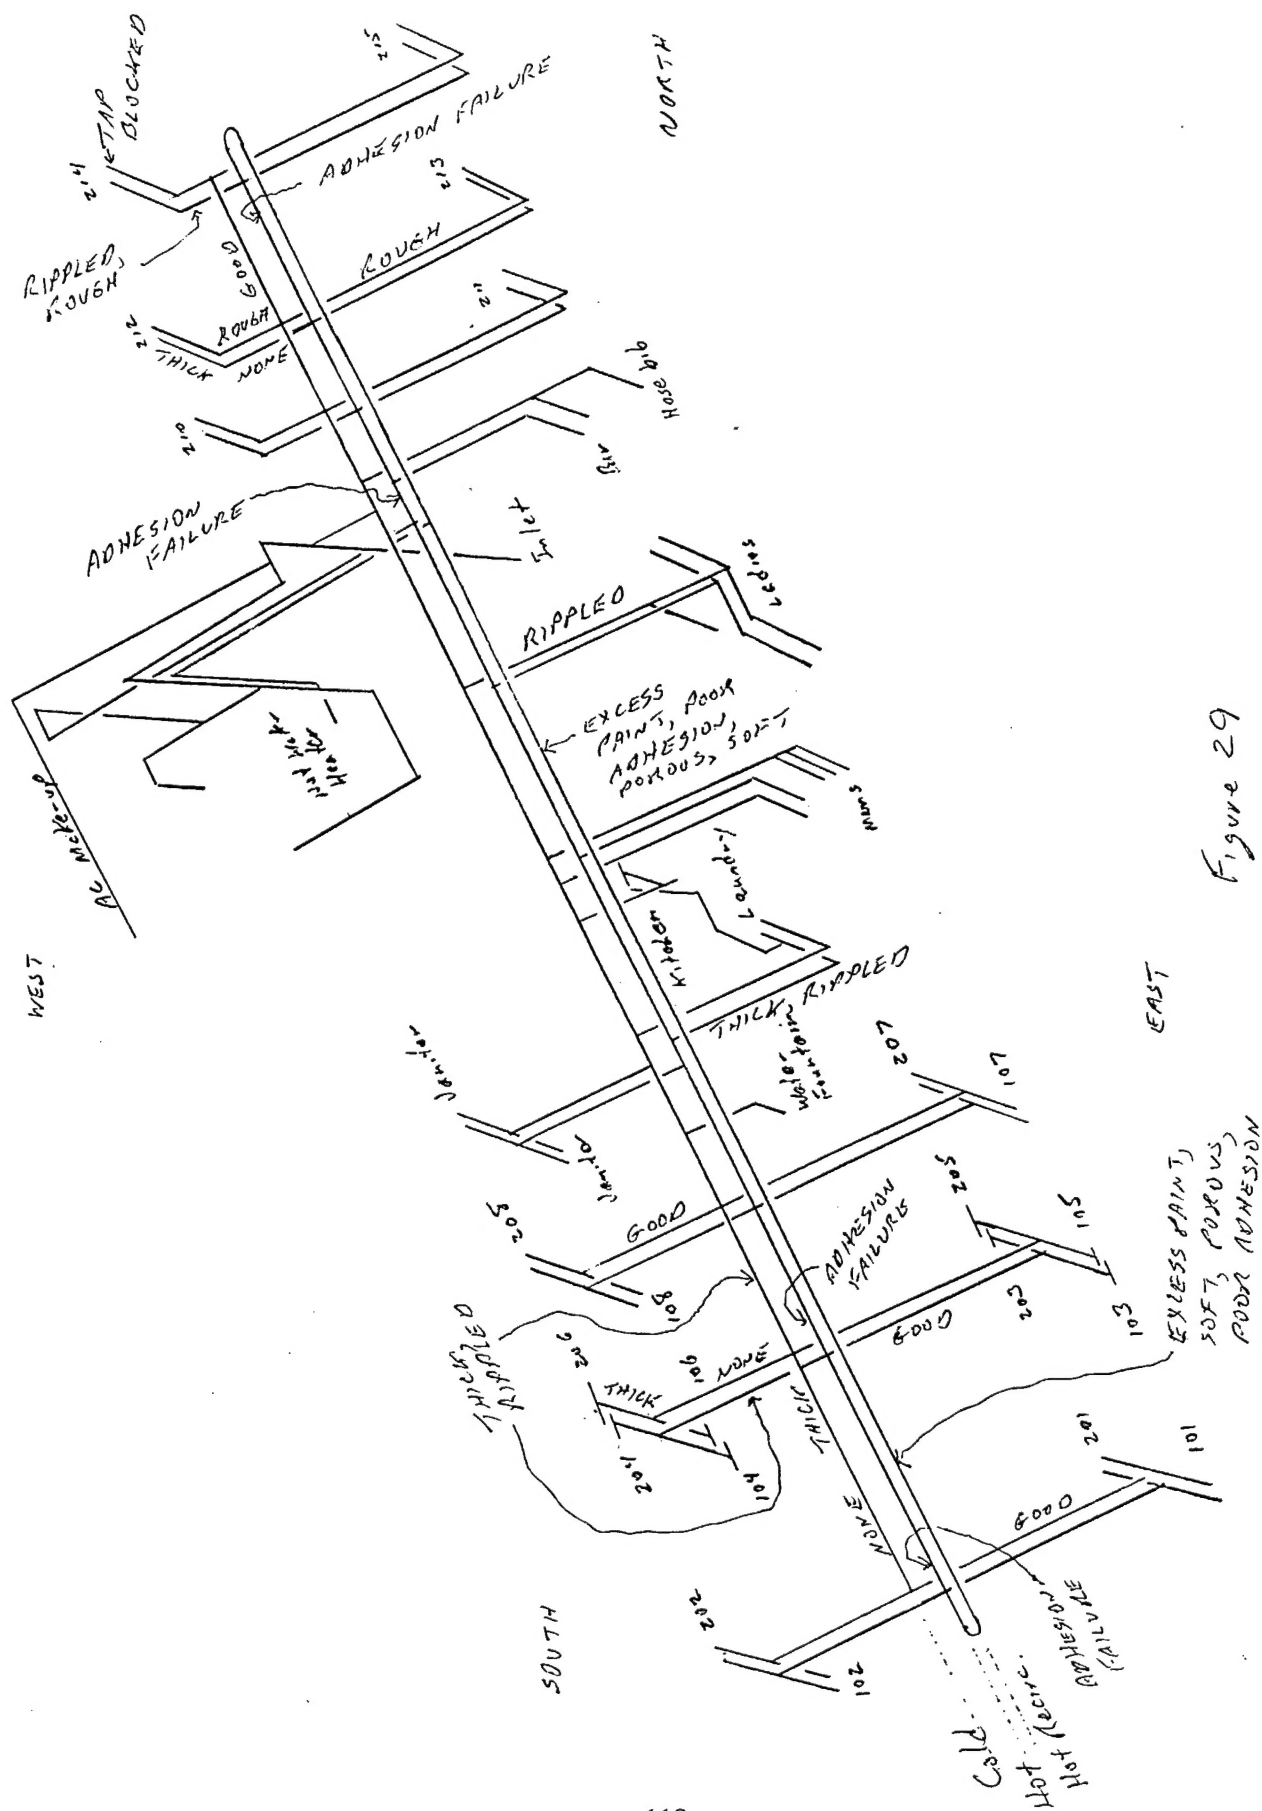
3. The piping was lined in three sections. Work in the north and mid-sections is adequate but contains minor defects such as variations in paint thickness, rippling of the paint surface, and a rough finish characteristic of grit entrapment. Large areas of the paint in the south end of the building are defective and are responsible for the blockage of the entire piping system.

4. During installation of the lining, air velocity through the mains was frequently insufficient to create the proper surface roughness for paint adhesion, especially at the top of the larger pipes. In many sections of larger pipe, there is no surface roughness at all on the top of the pipe. A rough surface is essential for painting copper and because it was not produced, paint detached from the top surface in some sections of pipe. Most significantly, however, air velocity was insufficient to remove dust from blast cleaning operations.

5. A critical error in this work was that dust from blasting was left in the hot water recirculating line at the south end of the building.
 - a) When paint was added, dust and paint combined to form a viscous paste which entrained air and formed an excessively-thick, poorly-adhering, porous crust. This was most severe in the hot water recirculating line at the south end of the building.

- b) In some locations an excessively thick porous lining was adjacent to uncoated pipe, indicating that paint mixed with blasting dust was thick and resistant to flow.
